**Flood Control Project Maintenance  
Levee Inspections**  
**LMA District Cover Sheet**  
**Spring 2020 Levee Inspection Results**

**Reclamation District No. 0017 Mossdale**

**Levee Inspection Report By Mile - Spring 2020**

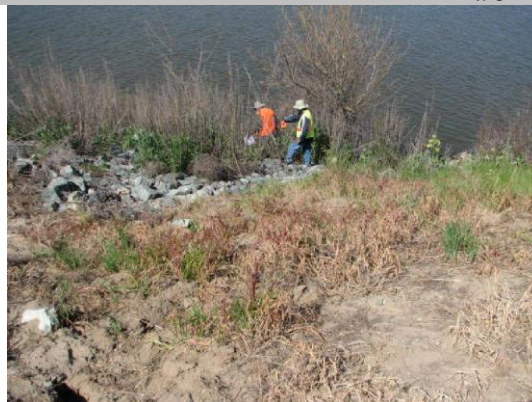
Photo 2 of 3 : UCIP\_SP\_2020\_40706\_72511.jpg

View of waterward toe--rip rap along pipe alignment.

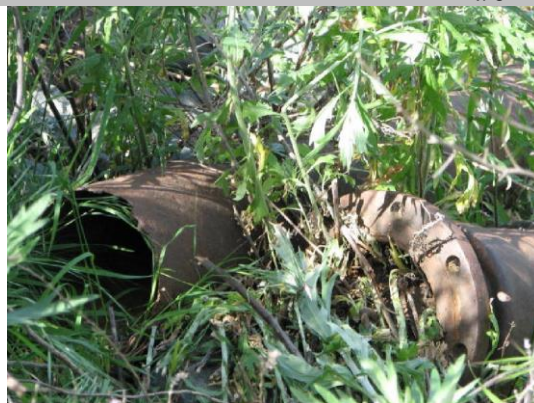
Photo 3 of 3 : UCIP\_SP\_2020\_40706\_72512.jpg

LM Start	<b>12.41</b>	Rating **	M	Issue No.	<b>151 (cont)</b>
LM End	<b>12.41</b>	Issue Type +	En	Location *	
Category	Supplemental		GPS Latitude/Longitude		
			Start	End	
Item	DWR UCIP Field Study		37.789976 °	37.789976 °	
			-121.306853 °	-121.306853 °	
DWR ID	807

Non-functional crossing pipe disconnected.

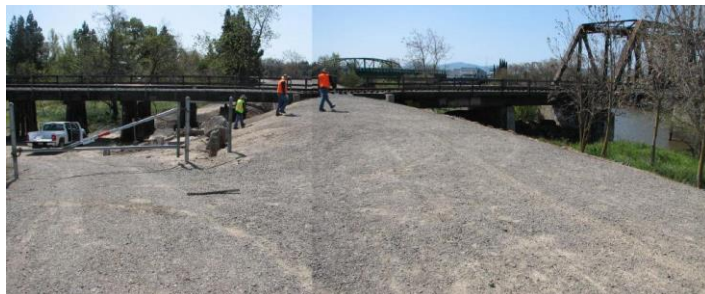
Photo 1 of 3 : UCIP\_SP\_2020\_40707\_72515.jpg

DS\_ID:60  
 FS\_ID:40707  
 EP\_NO: 14326  
 Repair Type: Non-Urgent  
 Crossing Status: Indicator Found  
 UCIP Comments: Wires exposed near levee crown unable to determine if these wires are part of the crossing. Need to contact owner to determine status of crossing.  
 FIELD\_STRUCT\_DESC: 4-inch galvanized iron communication cable through levee. Invert of conduit is 3.0 feet below levee crown. (4-inch fiber optic cable authorized under Permit No. 14326, 1986 - GTE Sprint Communications Corp.) [Additional Reference(s): DWR Levee Logs, 1981 and 2003]  
 FS Date: 2/4/2010

Overview of levee crown at crossing.

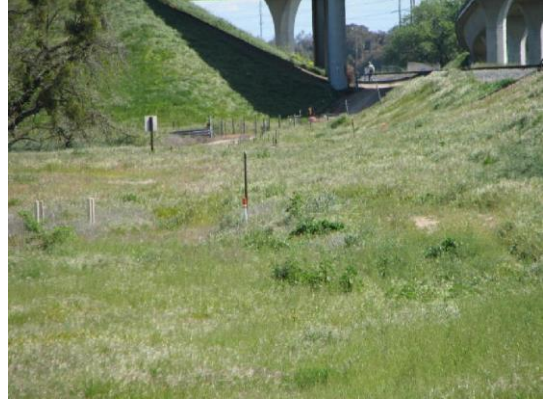
Photo 2 of 3 : UCIP\_SP\_2020\_40707\_72514.jpg

Crossing alignment along landward side.

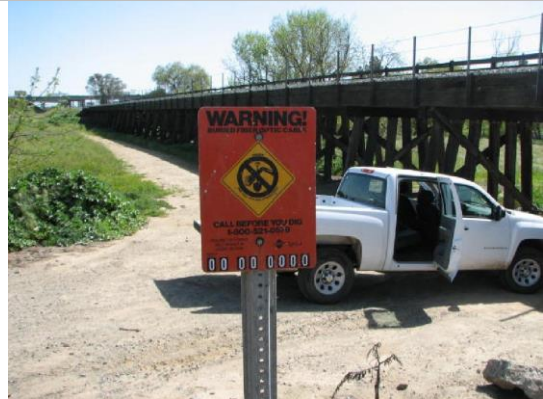
Photo 3 of 3 : UCIP\_SP\_2020\_40707\_72513.jpg

Conduit marker on landward side.

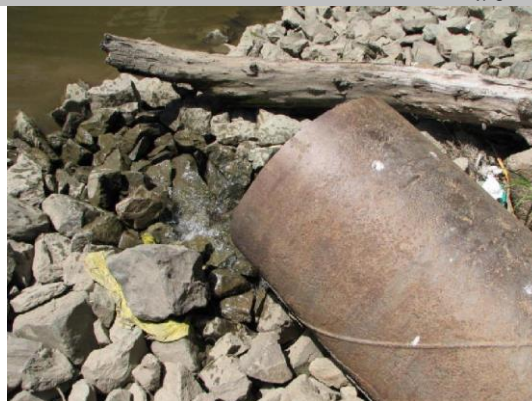
Photo 1 of 3 : UCIP\_SP\_2020\_45466\_72523.jpg

Pipe was running during field inspection.

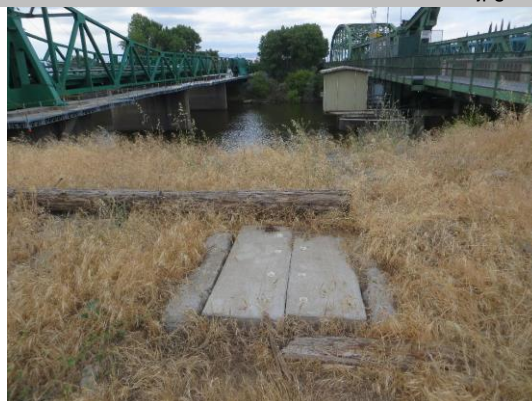
Photo 2 of 3 : UCIP\_SP\_2020\_45466\_74131.jpg

Concrete manhole on WS shoulder.

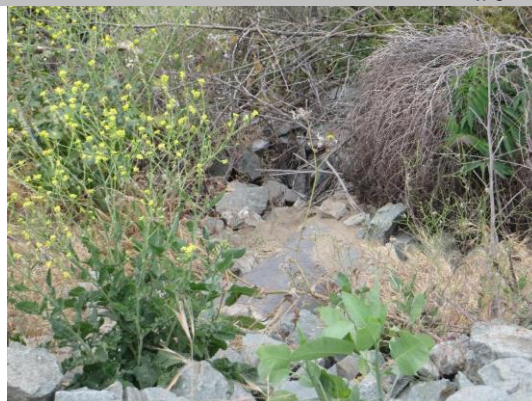
Photo 3 of 3 : UCIP\_SP\_2020\_45466\_74130.jpg

Comment Code						
Inspector Comment						
DS_ID:808 FS_ID:45466 EP_NO: 2366 Repair Type: Non-Urgent Crossing Status: Found UCIP Comments: Pipe exposed on WS slope where soil has been removed from around pipe. There does not appear to be any damage or repair at excavation. Pipe should be buried. FIELD_STRUCT_DESC: 22-inch steel drainage pipe through the levee, 10-feet below levee crown. 54-inch square, concrete manhole at the centerline of the levee between Manthey Road and the HWY 120 on ramp to I-5. (22-inch pipe authorized under Permit No. 2366, 1956 - State of California Department of Public Works Division of Highways District X) [Additional Reference(s): DWR Levee Logs, 1981, 2003, 22-inch listed. USACE San Joaquin O&M Manual Unit No. 2, May 1963, (HLM 12.74), 22-inch pipe] FS Date: 5/21/2015

Pipe exposed in excavated area on WS slope.

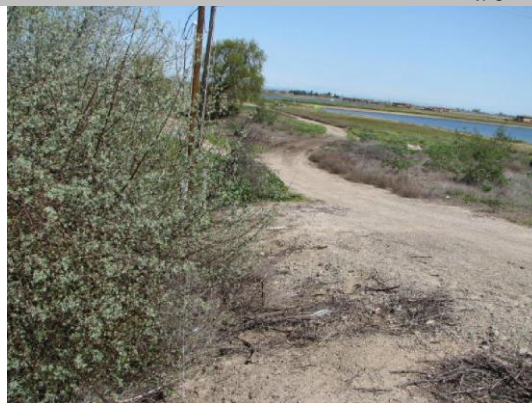
Photo 1 of 3 : UCIP\_SP\_2020\_40712\_72529.jpg

View of landward side.

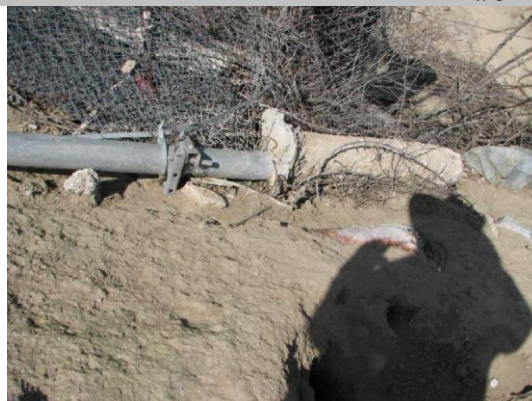
Photo 2 of 3 : UCIP\_SP\_2020\_40712\_72528.jpg

DS\_ID:65  
 FS\_ID:40712  
 EP\_NO: 14450  
 Repair Type: Non-Urgent  
 Crossing Status: Found  
 UCIP Comments: Need to contact owner to determine status of crossing.  
 FIELD\_STRUCT\_DESC: [Oakwood Lake Discharge Lines] 1 of 2. 18-inch steel drainage discharge pipe through levee at unknown depth below the levee crown. (two 18-inch pipes authorized under Permit No. 14450-1985 - R. H. Brown, remove existing 18-inch pipe) [Additional Reference(s): DWR Levee Logs, 1981 and 2003]  
 FS Date: 2/4/2010

Pipe section exposed on landward side.

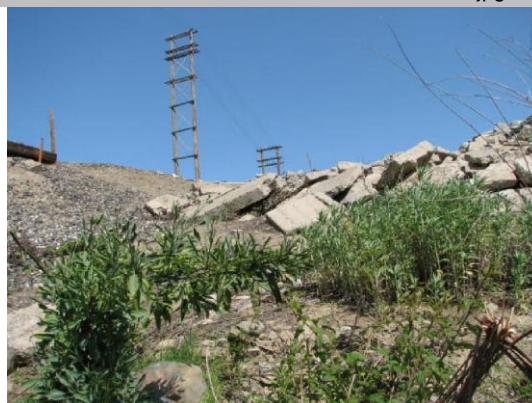
Photo 3 of 3 : UCIP\_SP\_2020\_40712\_72530.jpg

View of waterward slope.

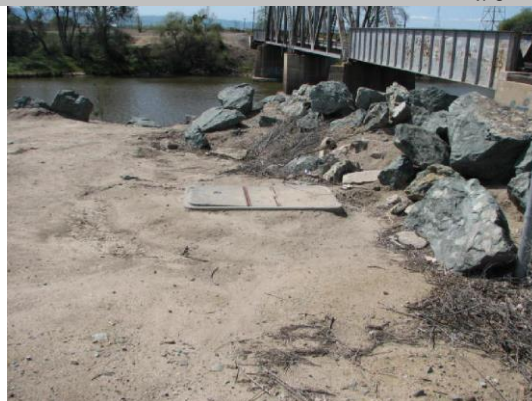
Photo 1 of 3 : UCIP\_SP\_2020\_40713\_72534.jpg

Precast concrete box located on levee shoulder.

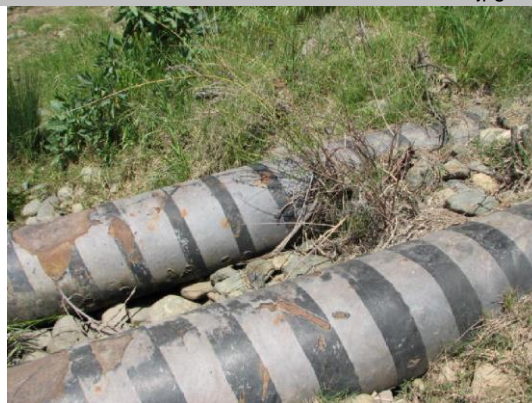
Photo 2 of 3 : UCIP\_SP\_2020\_40713\_72533.jpg

Pipes visible on waterward side.

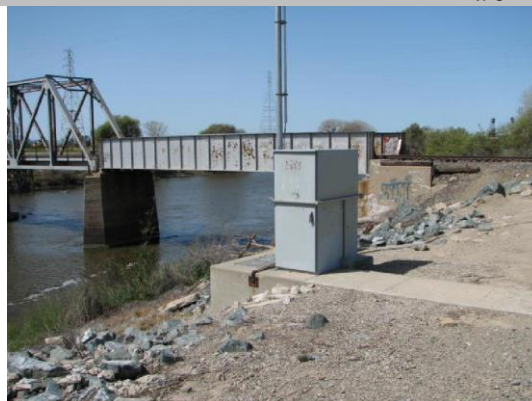
Photo 2 of 3 : UCIP\_SP\_2020\_40714\_72539.jpg

Control box and distribution box located on waterward shoulder.

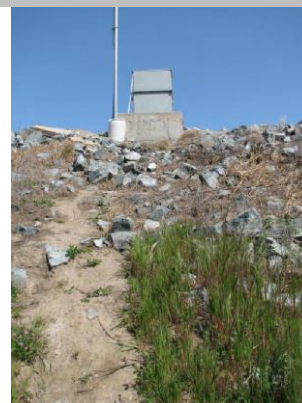
Photo 3 of 3 : UCIP\_SP\_2020\_40714\_72542.jpg

View of waterward side.

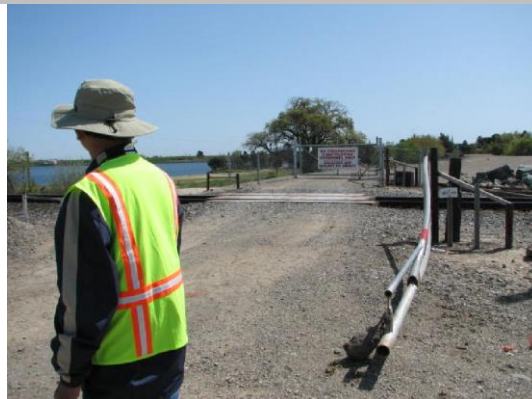
Photo 1 of 2 : UCIP\_SP\_2020\_45995\_72526.jpg

View of levee crown at crossing.

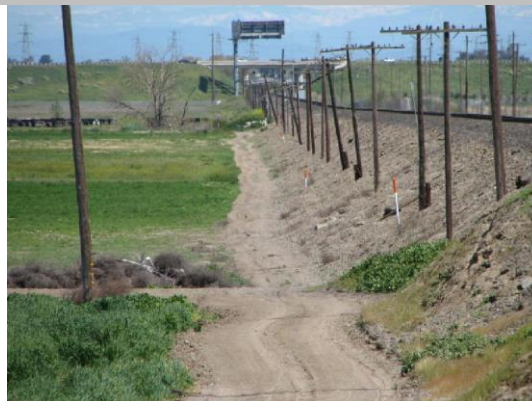
Photo 2 of 2 : UCIP\_SP\_2020\_45995\_72525.jpg

DS\_ID:67  
 FS\_ID:45995  
 EP\_NO: N/A  
 Repair Type: Non-Urgent  
 Crossing Status: Indicator Found  
 UCIP Comments: Markers visible on landward side only. Recommend contacting owner to confirm alignment and crossing.  
 FIELD\_STRUCT\_DESC: Submarine power cable through the levee and across the channel. [Additional Reference(s): DWR Levee Logs, 1981 and 2003]  
 FS Date: 2/4/2010

Markers visible along landward side.

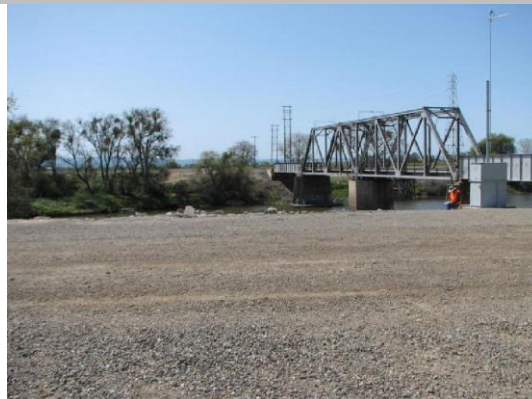
Photo 1 of 3 : UCIP\_SP\_2020\_40715\_72548.jpg

View of levee crown at crossing.

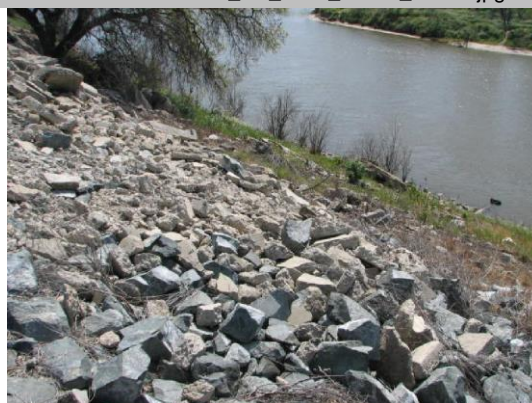
Photo 2 of 3 : UCIP\_SP\_2020\_40715\_72551.jpg

View of waterward side, photo 1 of 2.

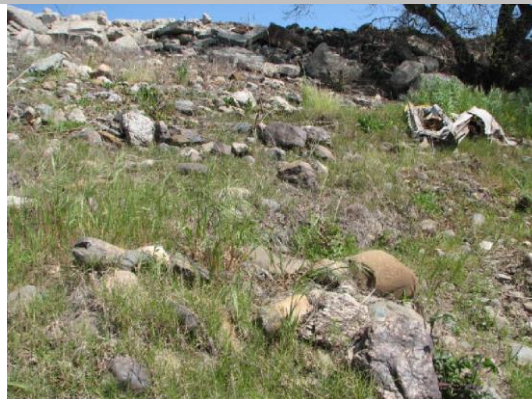
Photo 3 of 3 : UCIP\_SP\_2020\_40715\_72549.jpg

View of waterward side, photo 2 of 2.

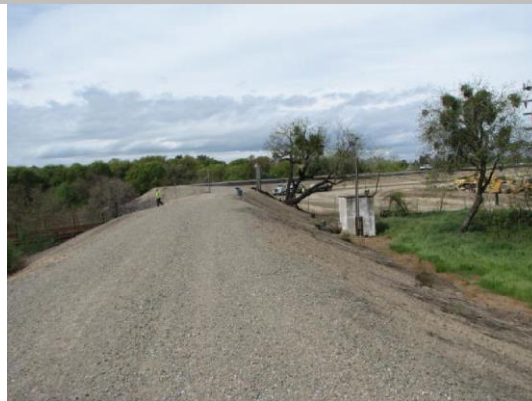
Photo 1 of 3 : UCIP\_SP\_2020\_40716\_72557.jpg

DS\_ID:69  
 FS\_ID:40716  
 EP\_NO: 15165  
 Repair Type: Non-Urgent  
 Crossing Status: Found  
 UCIP Comments: Pump was working during the survey. Levee toe erosion at waterward side. Recommend contacting owner to determine status and to evaluate erosion at waterward toe.  
 FIELD\_STRUCT\_DESC: 20-inch steel irrigation pipe through the levee, 1.7-feet below the crown. Pump on pile structure in the stream. Wooden walkway to the pump. concrete distribution box at the toe of the landside (LS) slope. (20-inch pipe authorized under Permit No. 15165, 1989 - Baird Lands, Inc., existing 18-inch pipe removed )  
 [Additional Reference(s): DWR Levee Logs, 1981 and 2003]  
 FS Date: 2/4/2010

Overview of levee crown at crossing.

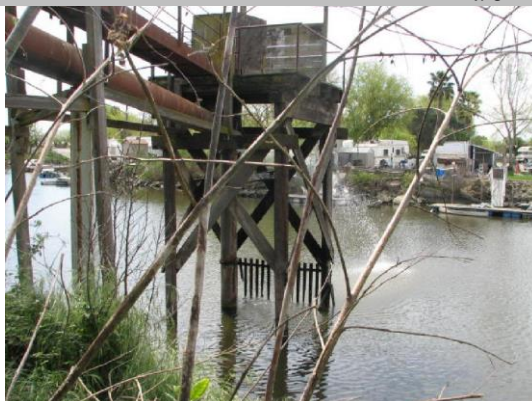
Photo 2 of 3 : UCIP\_SP\_2020\_40716\_72556.jpg

Pipe operable during survey.
